BUREAU OF LAND MANAGEMENT

RE: Minor Modification to the Skyline Mine No. 3 - Fault Zone in the 6th Right Bleeder

UTAH FUEL COMPANY
SKYLINE MINE No. 1
LOWER O'CONNOR-A SEAM
Approved Plan

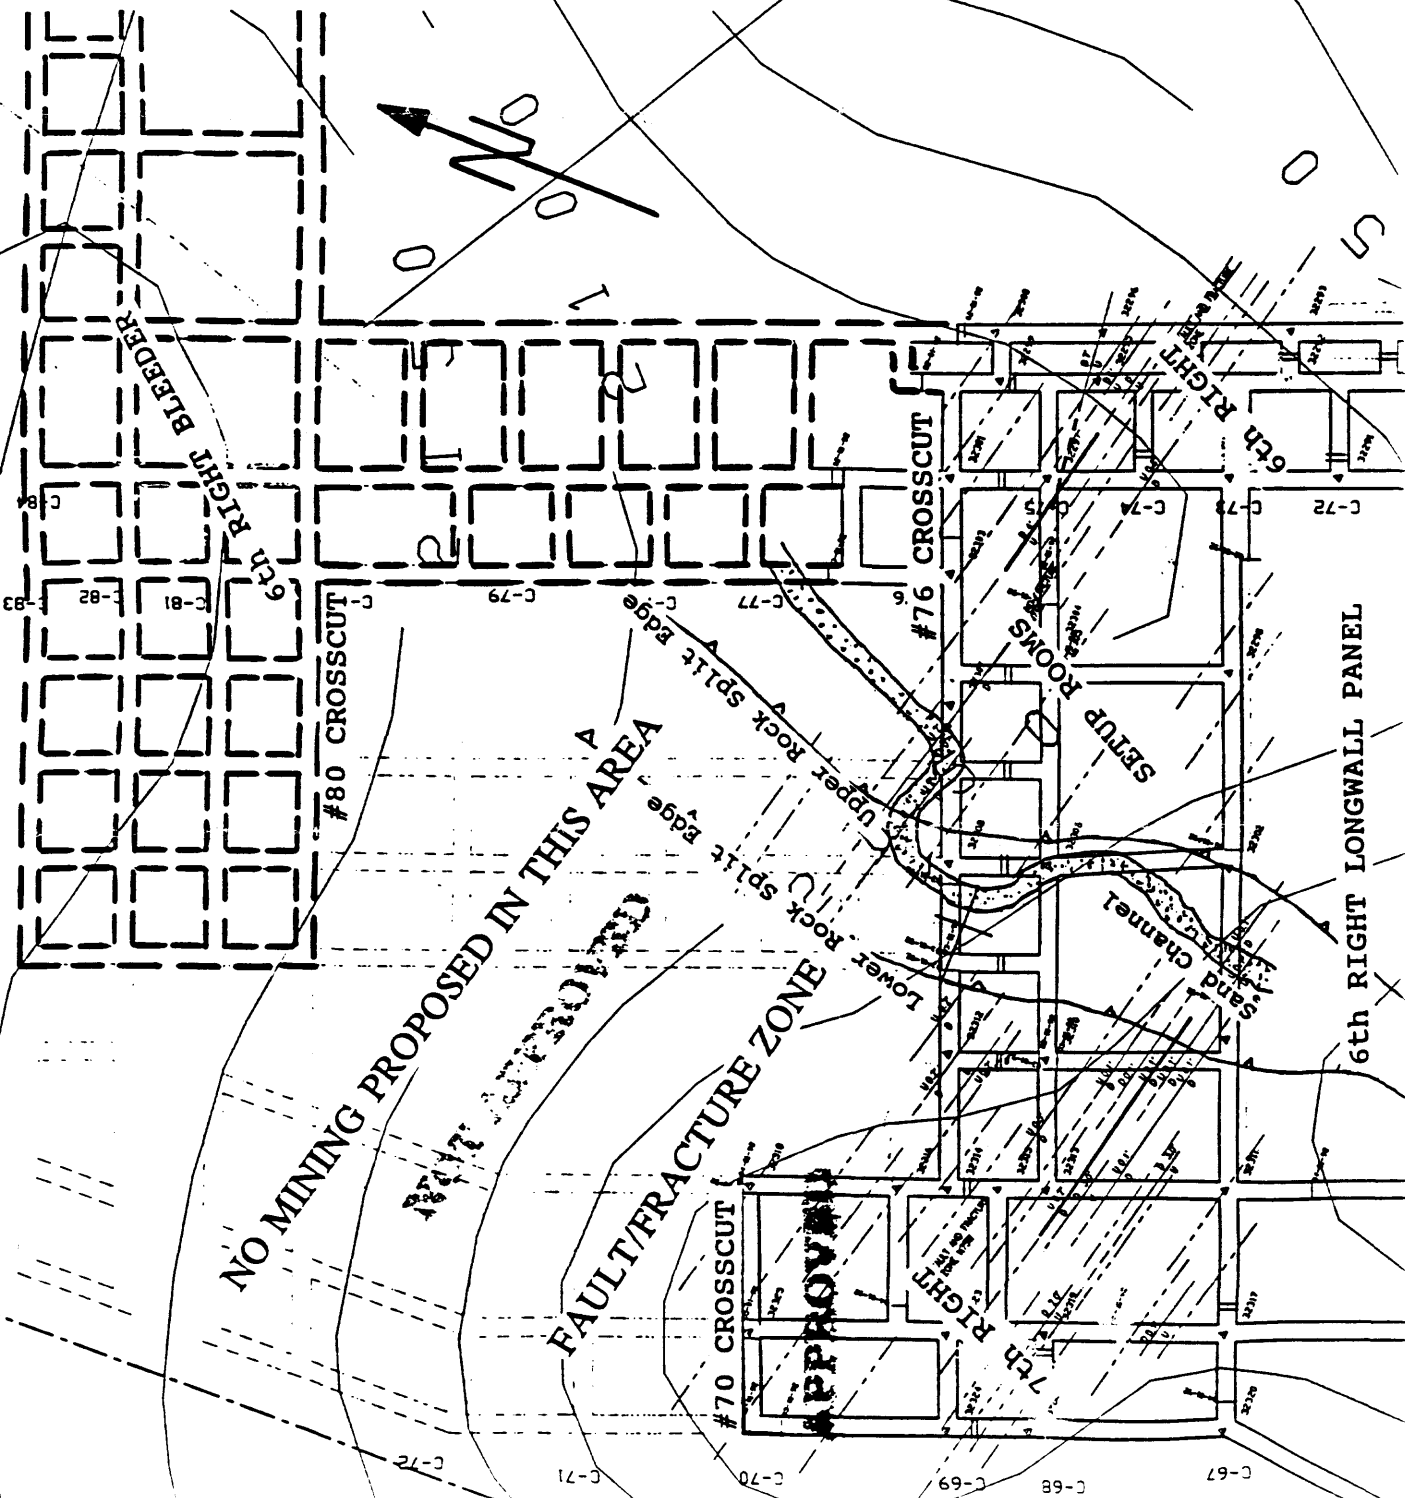
UFC's approved mining plan was to develop the 7th Right entries to the 6th Right bleeder and recover a portion of the reserves in the block of coal between #76 and #80 crosscuts with first mining. UFC is now proposing to stop mining the 7th Right entries at #70 crosscut and exclude any mining in the block of coal between #76 and #80 crosscuts (see enclosure).

According to UFC, a fault zone with a high degree of sympathetic faulting was encountered while developing the setup rooms for the 6th Right longwall panel. Adverse roof and rib conditions are associated with this zone.

A BLM mining engineer from the Price Coal Office inspected the mine on June 22, 1992. During the inspection of the 6th Right and 7th Right entries, a fault zone comprised of two major faults with a very high degree of sympathetic faulting associated with the area between the faults was observed. The fault zone is approximately 700 feet wide, trending N60W and traverses the 6th Right longwall panel setup rooms. Solid steel mats, roof trusses, and a combination of seven and ten foot roof bolts were used to control the fractured roof and the weak rib in this area. It is also not known how far the fault zone continues north of the 6th Right longwall panel setup rooms.

Based on this information, the BLM concludes that it is not feasible for the company to cross the fault/fracture zone from the 7th Right entries. However, there is potential for developing the northern portion of the reserves in this block which are unaffected by the fault zone from the 6th Right bleeder entries. Termination of this development will be based upon where the fault zone is encountered, the condition of the roof and ribs, and verification by the BLM.

Therefore, the BLM has authorized UFC to stop mining the 7th Right entries at #70 crosscut. We estimate that approximately 28,000 tons of additional coal in the northern portion of the reserves in this block between #76 and #80 crosscuts could be recovered from the 6th Right bleeder entries. UFC must either follow the approved mining plan to obtain the additional recovery of the reserves in question or submit appropriate justification for BLM approval explaining why additional recovery is not possible.
